RESOLUTION NO. 17-131

A RESOLUTION OF THE CITY COUNCIL OF THE CITY OF PASO ROBLES  
AUTHORIZING THE REMOVAL OF MULTIPLE OAK TREES  
IN RELATION TO OAK CREEK PARK / SENIOR CENTER (OTR 17-016)  
AND THE NORTH VINE STREET PAVEMENT PROJECT (OTR 17-017)

**RE:** Addendum to June 14, 2017 oak tree removal letter

**Re:** Tree Health Assessment for Nate Wyatt, 270 Scott Street, Paso Robles, CA

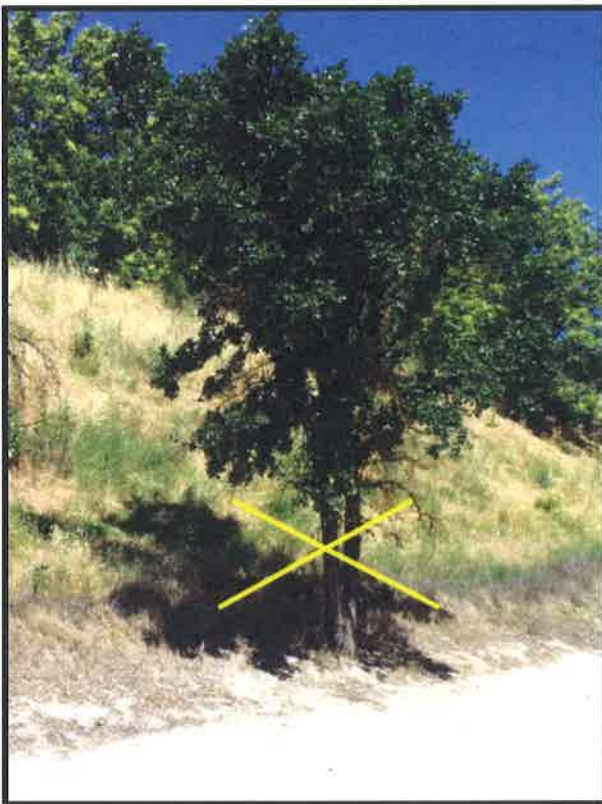
**Tree 7** is a 14" diameter two-stem valley oak located at the west side of Vine Street approximately ¼ of the way north of 32<sup>nd</sup> street toward Caballo Road. This tree has a major area of included bark in the trunk which makes it prone to failure. It is located within the grading zone of the project and will impede road construction. This tree should be removed.

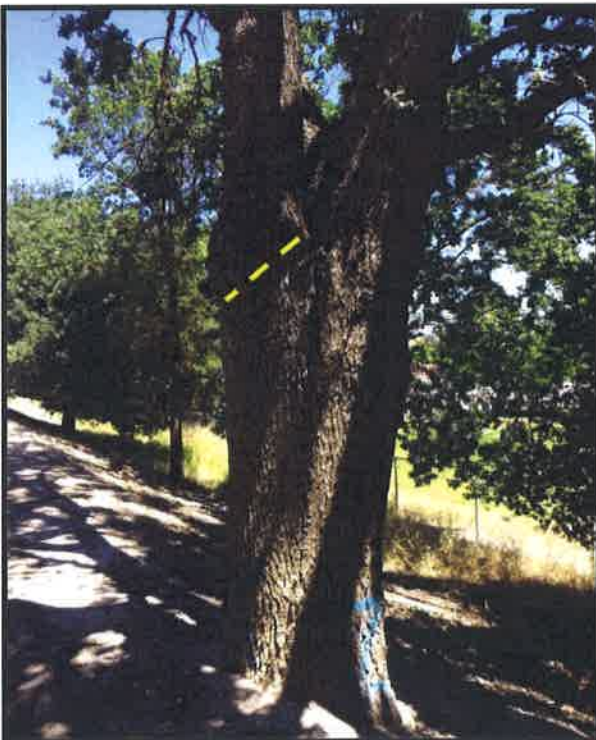
**Tree 10** is a 29" diameter valley oak located on the east side of Vine Street approximately ½ way between 32<sup>nd</sup> street and Caballo Road. This tree has a major area of included bark in the trunk which makes it prone to failure. The stem leaning over the roadway should be removed to eliminate the risk of branch failure. Yellow dashed line indicates branch to be removed. No significant grade cuts are planned for this area of road construction. Exploratory excavations in the critical root zone of the roadbed found no significant roots. This tree can be retained.

Critical Root Zone Excavation & Inspection				
Tree #	Species	Location	Comments	Recommendations
10	Valley oak	East side of Vine St. at Mid project	Two roots ranging 4 and 6 inches diameter of were found at the base of the tree at a depth of 16 inches below grade. Inspections for roots were performed in the roadbed approximately 6 feet front the trunk of the tree and no roots were found. This location will have fill applied to the roadbed to a depth of approximately 8". I do not foresee any root damage being caused by grading machinery.	Recommend meandering road around tree for 4' to 6' for clearance from trunk. Arborist supervision during grading or fill activities within the CRZ of this tree. All tree protection measures recommended in the original tree protection plan shall also be implemented.
22	Valley oak	West side of Vine St. ¼ distance north of 32 <sup>nd</sup> St. toward Caballo.	Excavations were made 4 feet from the trunk in the roadbed. No roots measuring larger than 1/8 inch diameter were found. This location will have fill applied to the roadbed to a depth of approximately 8". I do not foresee any root damage being caused by grading machinery.	Recommend meandering road around tree for 4' to 6' for clearance from trunk. Arborist supervision during grading or fill activities within the CRZ of this tree. All tree protection measures recommended in the original tree protection plan shall also be implemented.

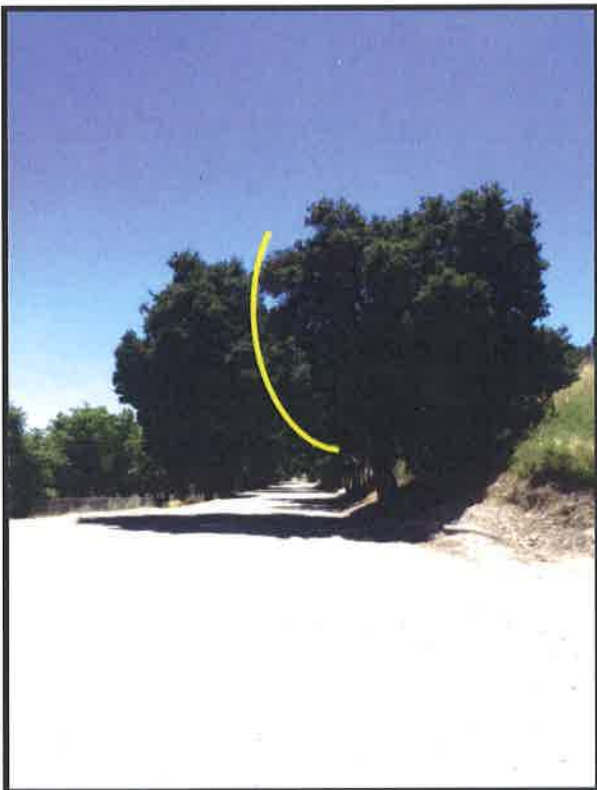
**Tree 24** is a 28" diameter coast live oak located at the northwest corner of Vine Street and Caballo Road. The tree is at the edge of the construction footprint. No significant grade cuts are planned for this area of road construction. Exploratory excavations in the critical root zone of the roadbed found no significant roots. This tree can be retained. The tree creates a visual barrier down Vine Street for drivers turning south off Caballo Road. Pruning for 15 feet of clearance above the roadway to allow for fire trucks and other large vehicles to pass beneath will be needed. Yellow line in picture below indicates approximate reduction of canopy.

24	Coast live oak	Southwest corner of Vine Street and Caballo.	Excavations were made 4 feet from the trunk in the roadbed. No roots measuring larger than 1/8 inch diameter were found. This location will have fill applied to the roadbed to a depth of approximately 6". I do not foresee any root damage being caused by grading machinery.	Recommend meandering road around tree for 4' to 6' for clearance from trunk. Arborist supervision during grading or fill activities within the CRZ of this tree. All tree protection measures recommended in the original tree protection plan shall also be implemented.

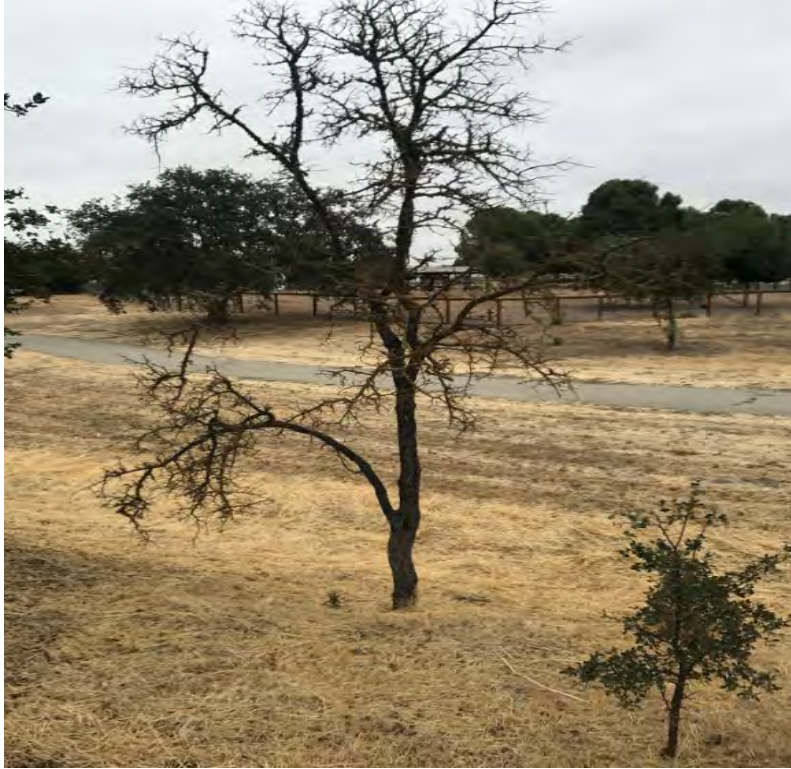
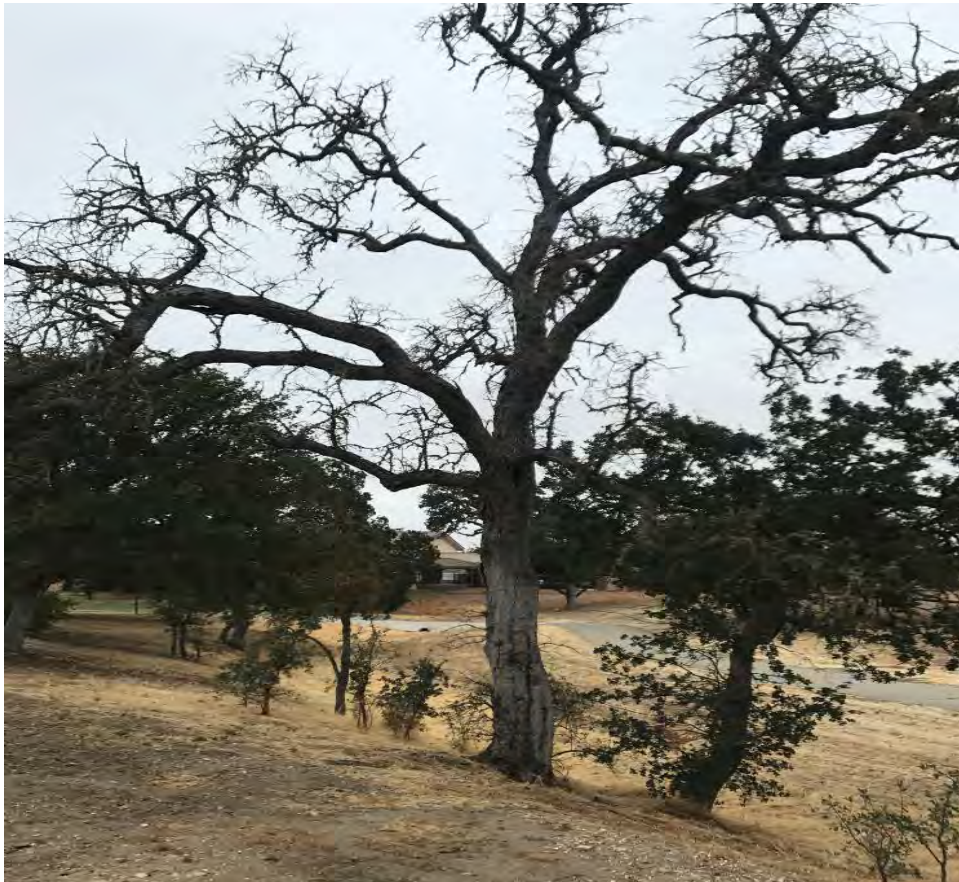
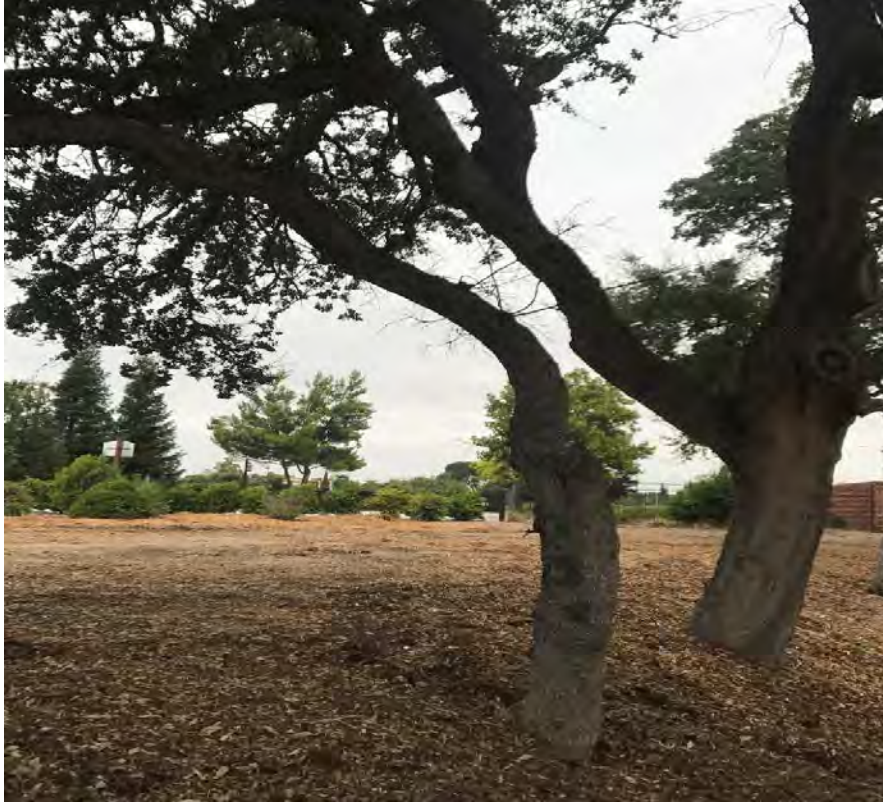
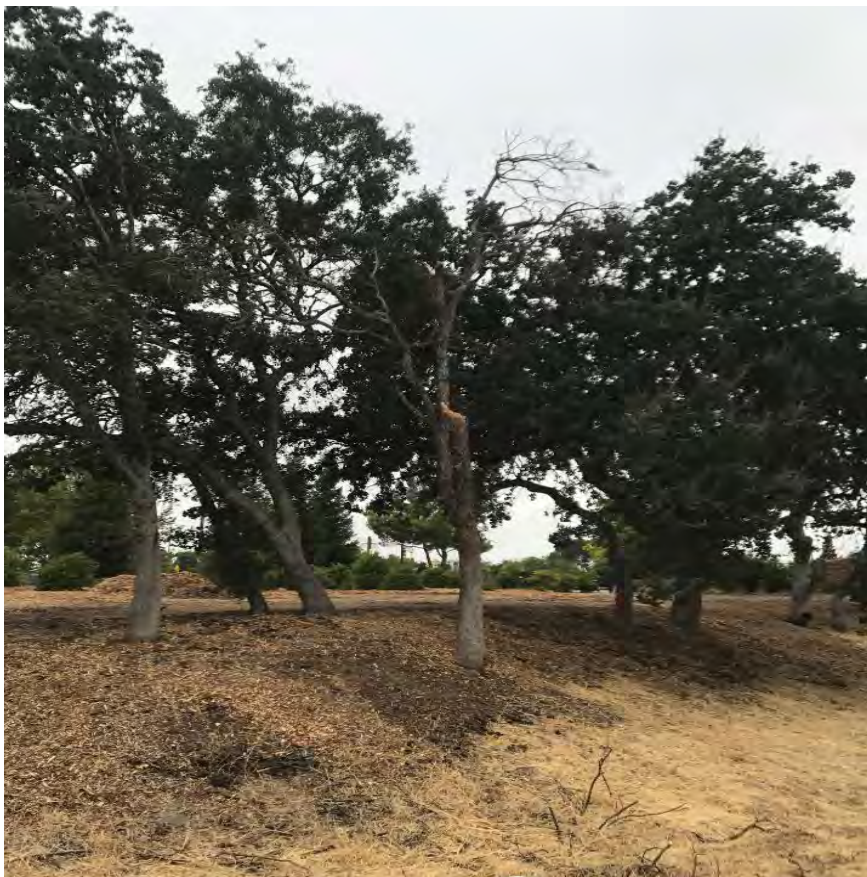
The three live oaks are all in a cluster with diameters of 23, 12, and 16 inches. There are obvious signs of what we believe are ambrosia beetles (*Monarthrum scutellare*). We occasionally see trees that have been killed by these beetles that bore into the vascular cambium, lay eggs and the larvae kill the tree. They tend to attack trees that have been weakened by stress due to construction or drought. Obviously, no construction has occurred at this site so drought stress is most likely the cause. Many times, a nearby tree will not have any damage from them even though they killed an adjacent tree.

The fourth tree is a blue oak that is 12 inches in diameter. It is hard to determine what may have killed this tree but there are a lot of ground squirrel holes at the base of the tree. The squirrels will chew on the moist roots for water during the hot months. This easily could have weakened the tree to the point of death.

The fifth tree is a 13 inch blue oak that was very heavily suppressed under another healthier tree. In the past, the entire top was pruned off possible due to being verticle at about four to five feet off of the ground. There was little to no foliage left for photosynthesis and it died. Not uncommon for a small tree under the canopy of a large one.

The sixth tree is also a blue oak of 22 inches diameter. The death of this tree is a bit more of a mystery. There is a large trunk wound on the east side near ground level. This could have led to death by oak root fungus (*Armalaria sp*). Other than that, there are not other outer signs that could have caused the death.

The seventh tree is a small 6 inch diameter blue oak. Looked like a healthy tree. Possibly died due to a smaller root system during th drought. Otherwise, unknown.

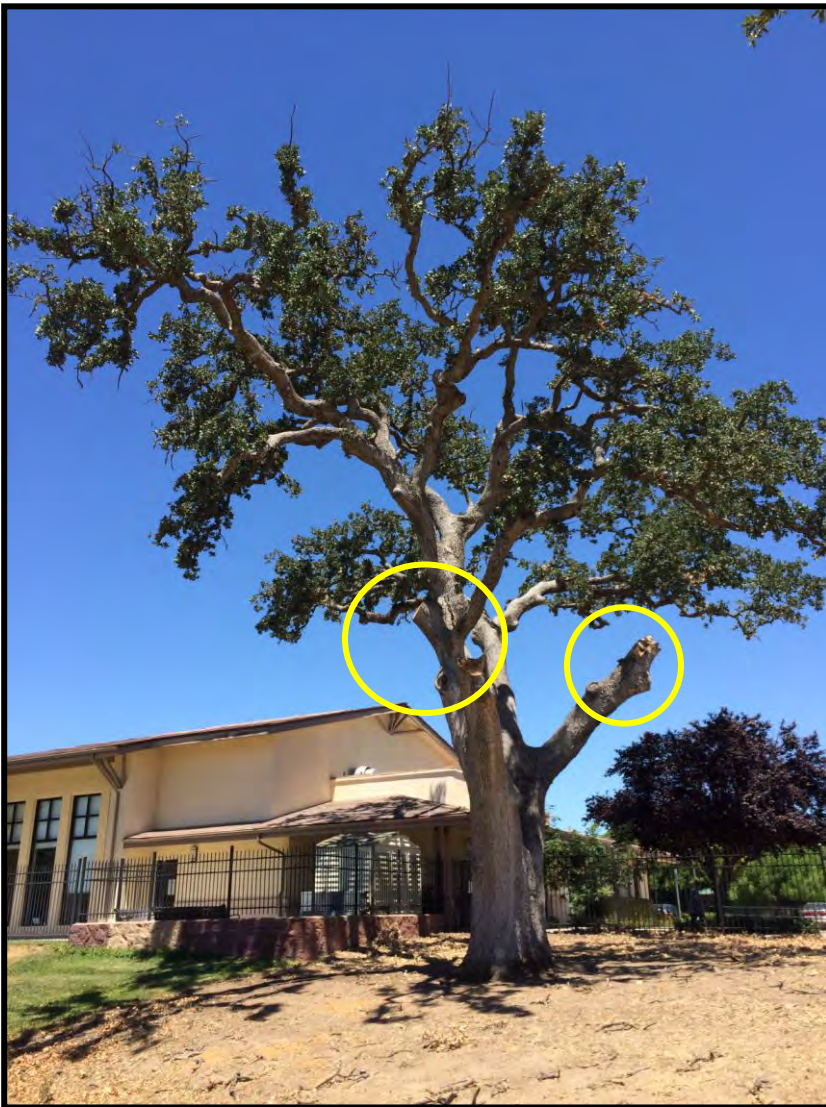
- The tree was a single stem with a **\*diameter at standard height (DSH)**, measured at 4.5 feet above ground level, of 50 inches. The tree height was approximately 60 feet with a **\*crown** spread of approximately 60 feet. See Appendix A- Photo1.

- The tree was located 30 feet to the southeast, rear corner of the senior center. See Appendix A- Photo1.
- The tree was within striking distance of the senior center.

- The **\*canopy** was declining, indicated by some branches not being fully leafed-out and live crown at approximately 50% of normal. See Appendix A- Photo1.

- I observed recent and past large **\*scaffold** branch failures due to large areas decay. See Appendix A- Photos1-3.
- There was root decay indicated by white fungus at the **\*root-crown** on the west side of the tree. See Appendix A- Photo 4.

**Photo 1-** View of tree from southeast. Scaffold failures indicated by yellow circles.

**Recommendation:** This tree is diseased beyond correction and should be removed as soon as possible.

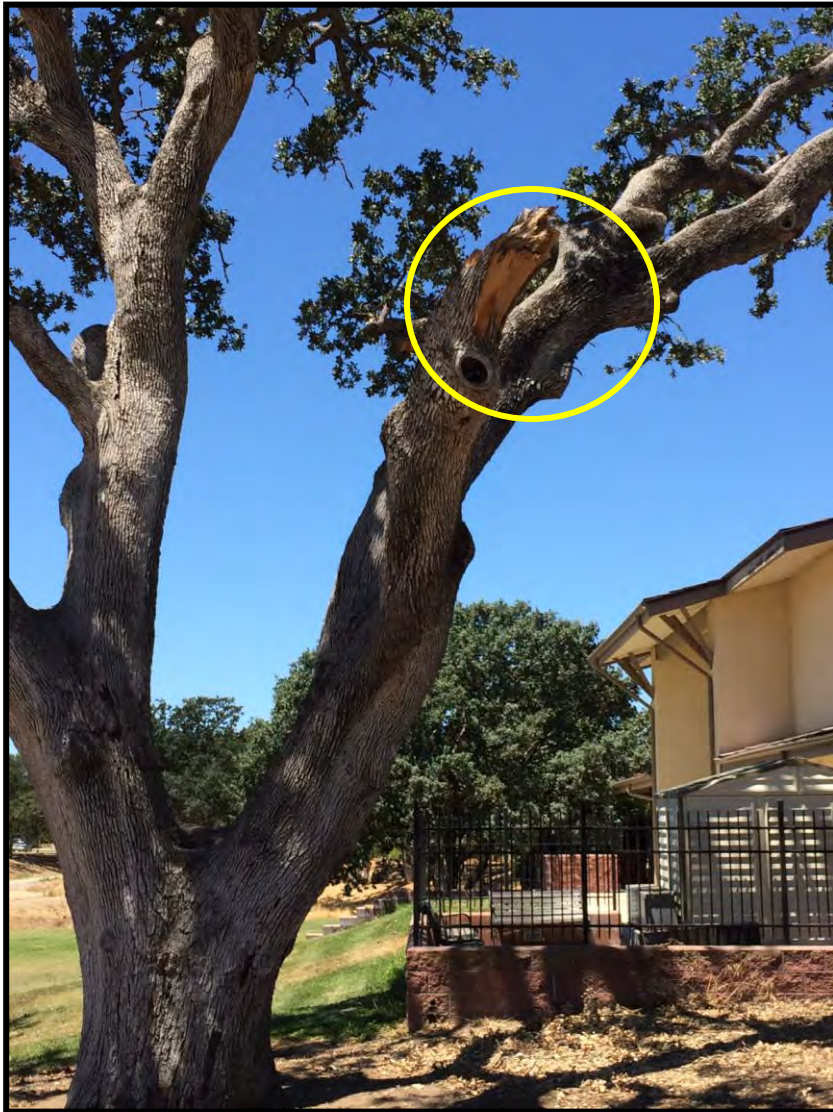
The main issue with the tree is a Phytophthora fungal infection, which is blocking the vascular system of the tree and causing areas of the tree, including large branches, to die or decline. Recent scaffold failures occurred in July 2017. I also observed older scaffold branch failures. Remaining branches are in similar condition as previously failed branches and have a high likelihood of failing.

Photo 2- Recent scaffold failure- July 2017- Indicated by yellow circle.

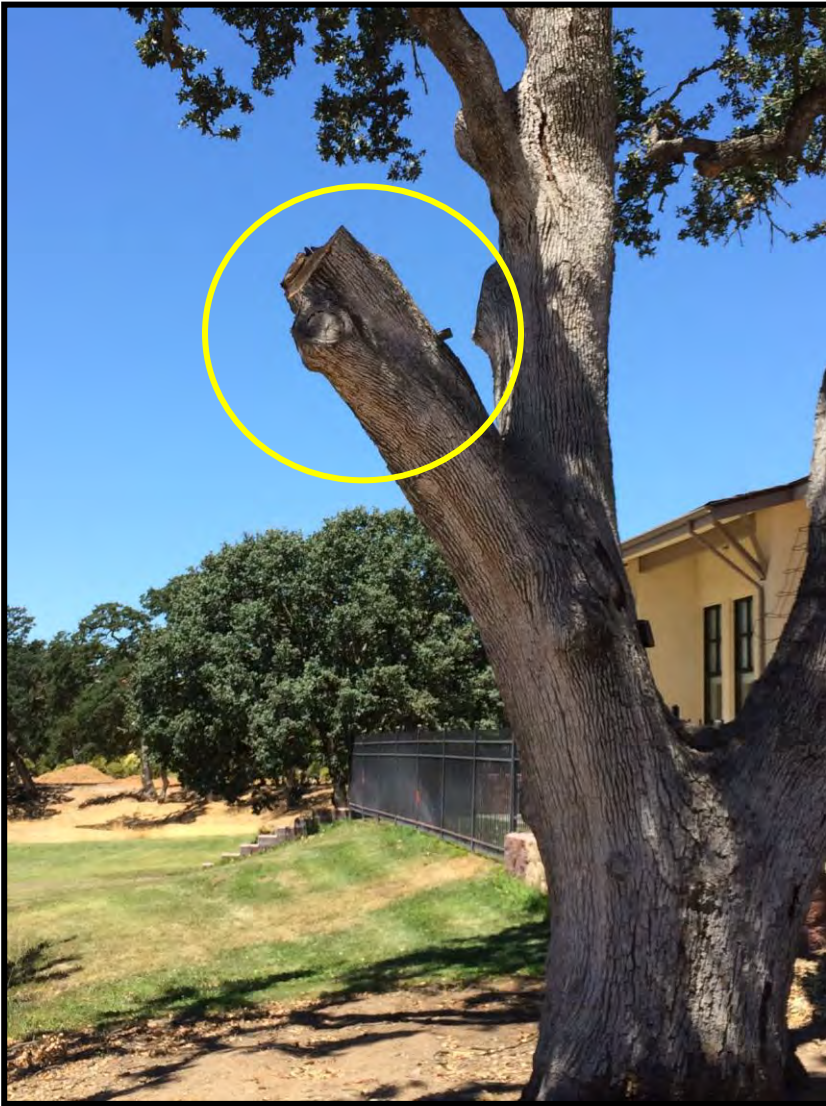
Photo 3- Older scaffold -branch failure indicated by yellow circle.

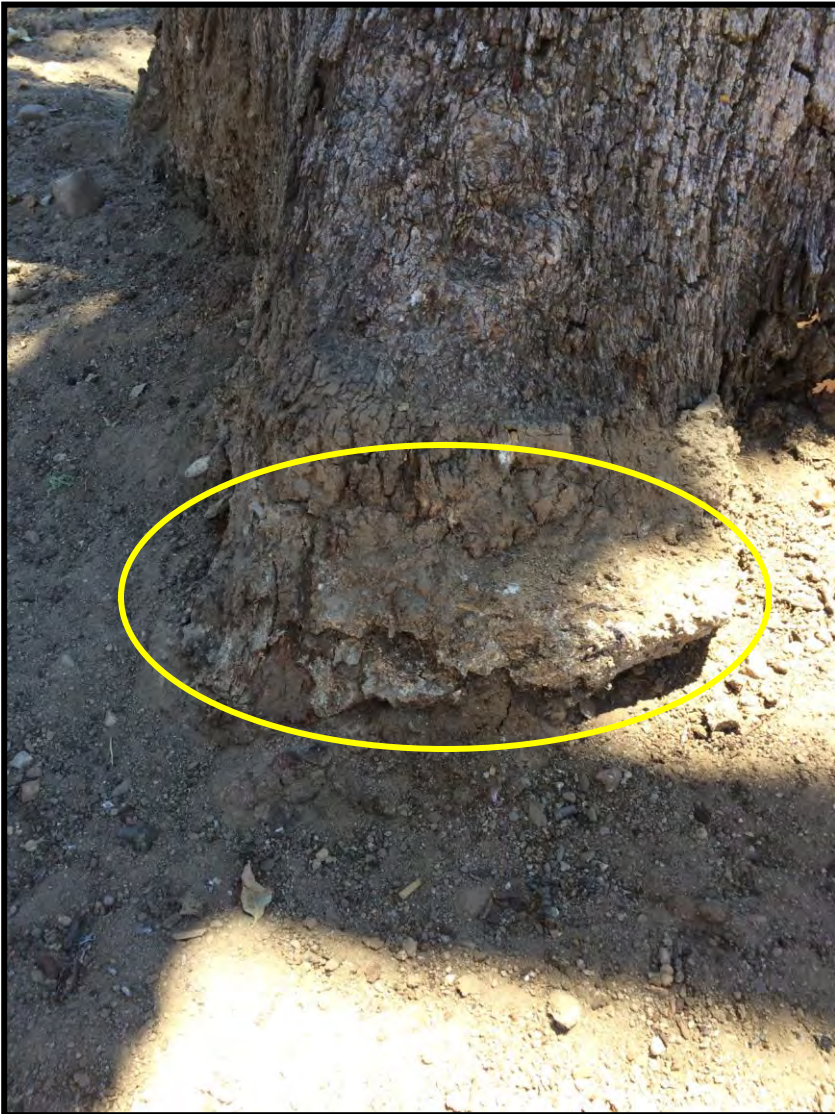
A secondary fungal infection caused by oak root fungus (*Armillaria mellea*) a known decomposer of roots is also contributing to root rot. Root rot has begun to decay anchor roots and makes the tree prone to complete failure.

**Photo 4-** Fruiting fungal bodies at root crown indicated by yellow circle

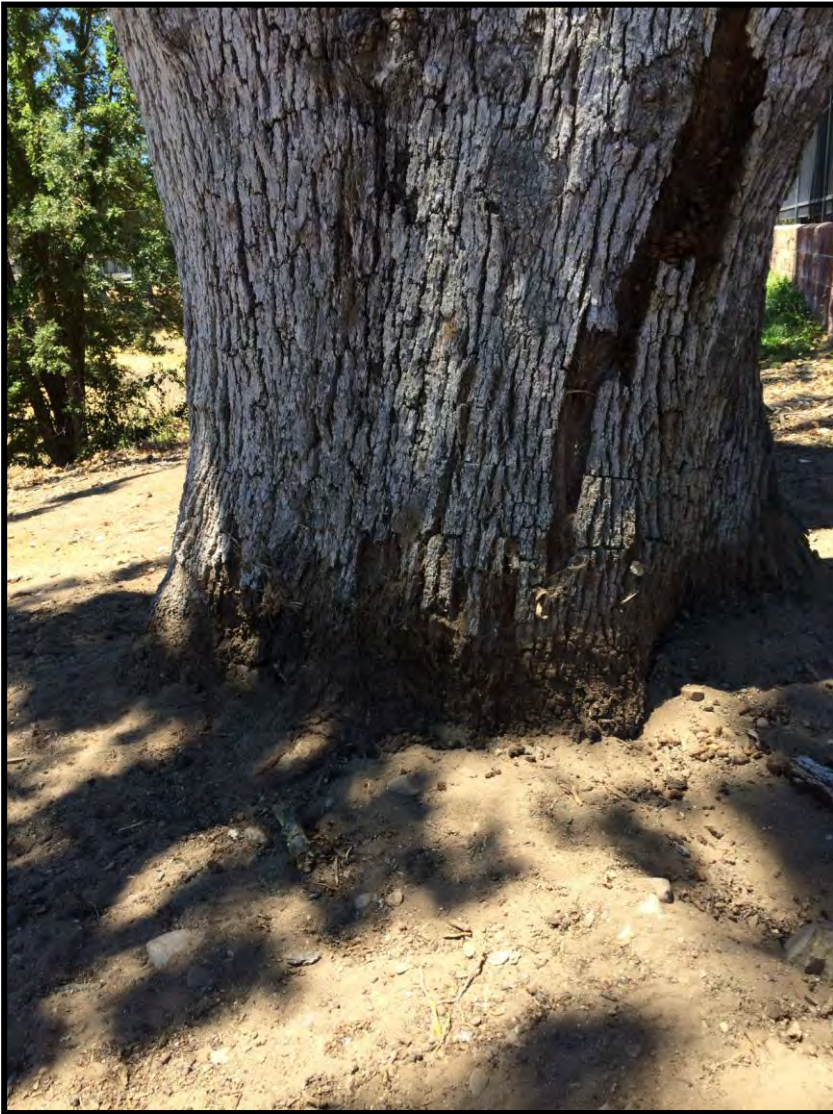
- I observed large areas of shedding and dead bark on the lower trunk at west side of tree. See Appendix A- Photo 5.
- Multiple cankers and bark shedding throughout the tree in scaffold branches. See Appendix A- Photo 6.

**Photo 5-** Shedding bark on lower trunk indicates root rot and vascular disease.

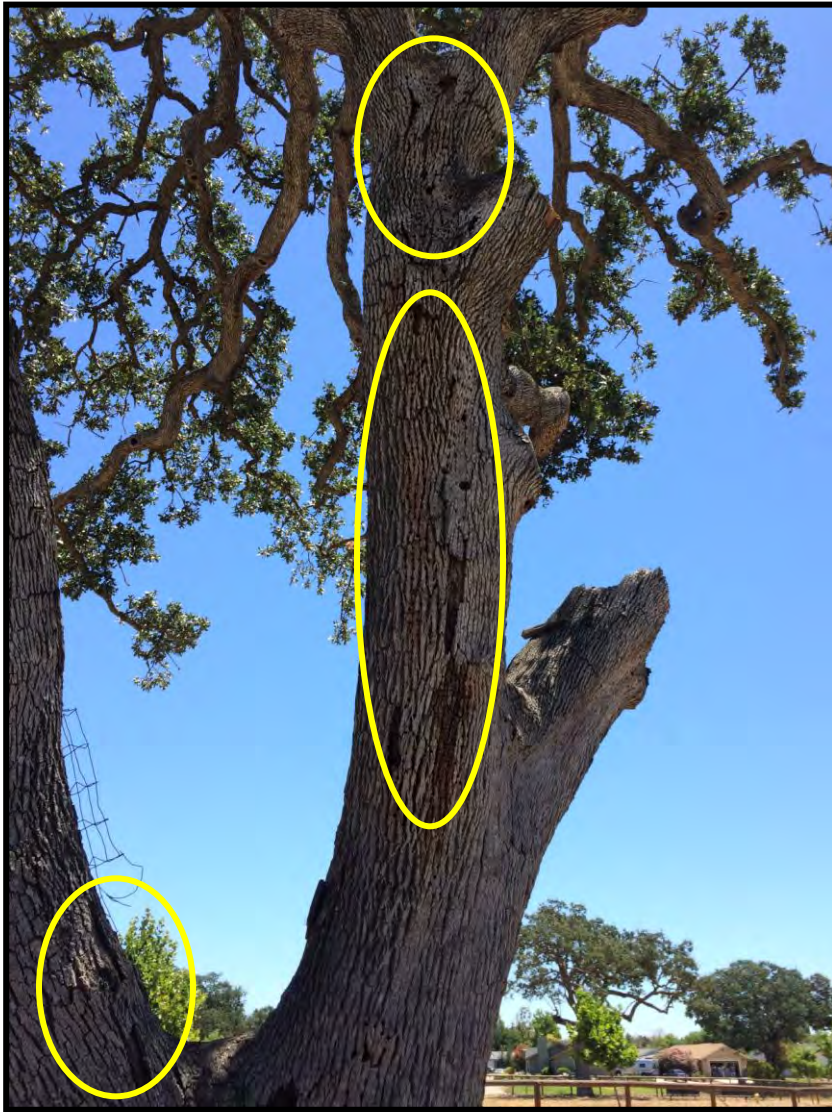
**Photo 6-** Canker and shedding bark on scaffold branch indicated by yellow circles. Cankers are caused by *Phytophthora* fungus.
